BUREAU OF SHIPS GROUP TECHNICAL INSPECTION REPORT

① OPERATION CROSSROADS,
U.S.S. FALLON (APA81)
TEST ABLE [U].

OPERATION CROSSROADS

USS FALLON (APA81)

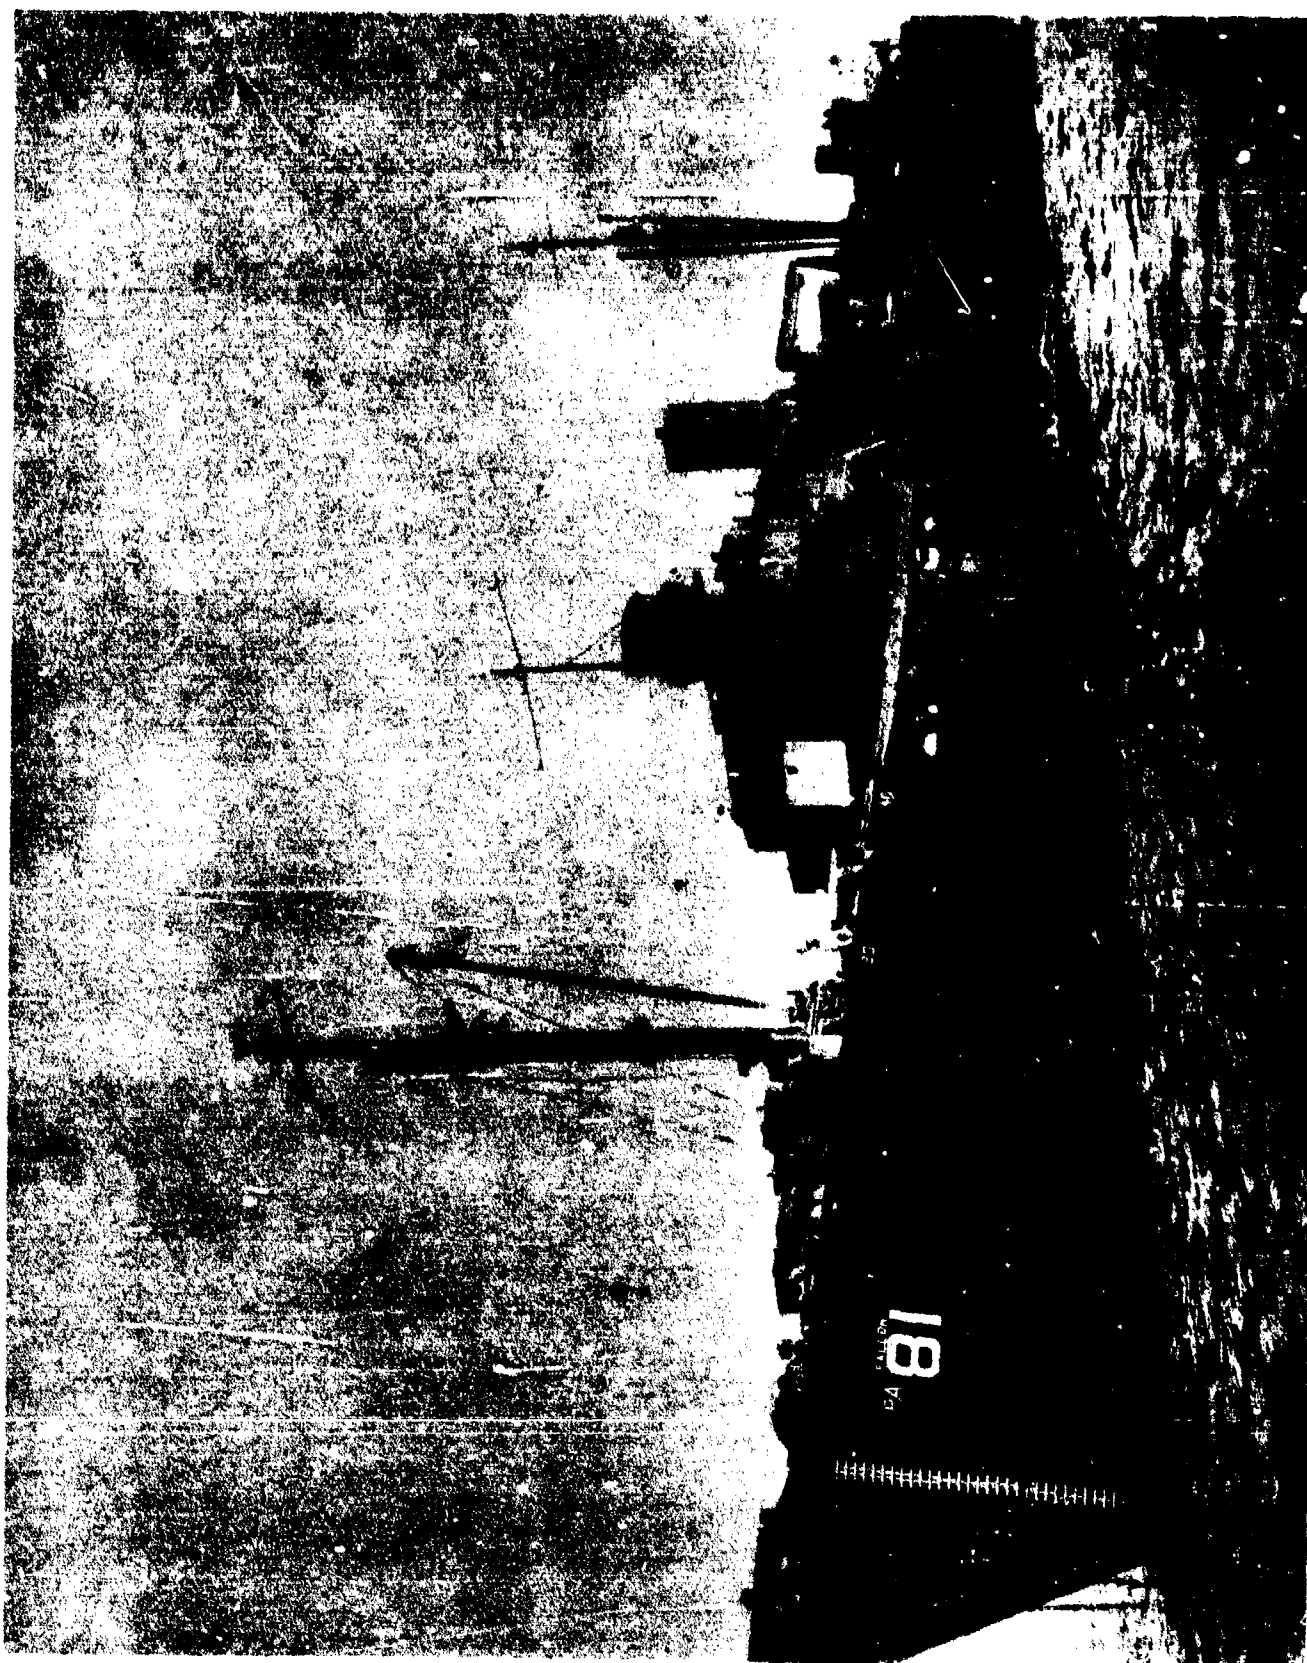
AA-CR-227-50-71. Exterior view on port bow after Test A.

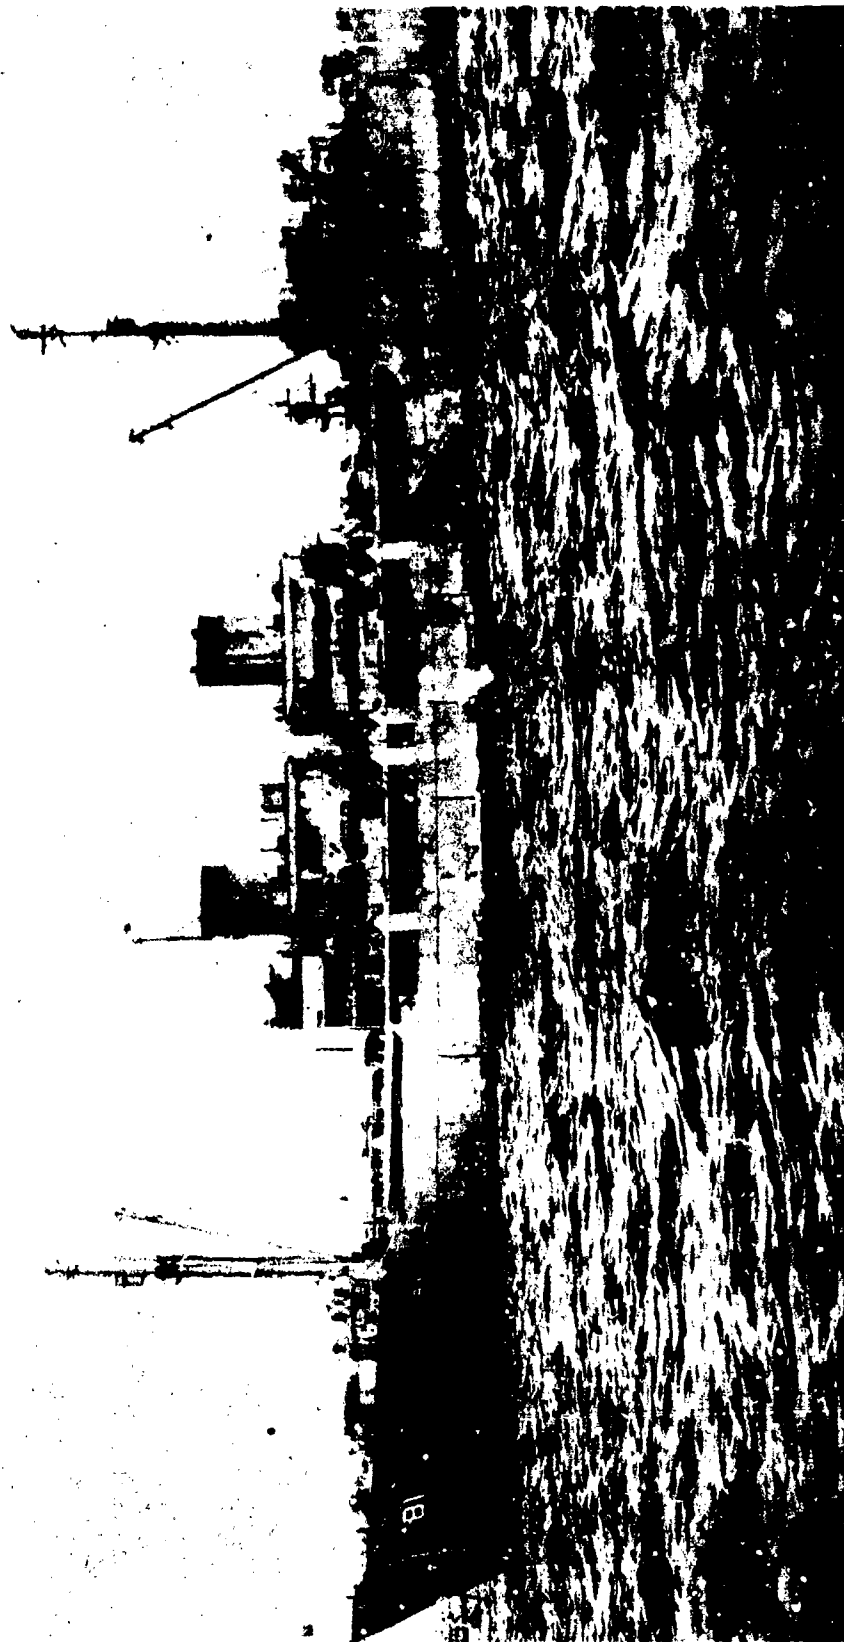
AA-CR-227-50-78. Exterior view on port beam after Test A.

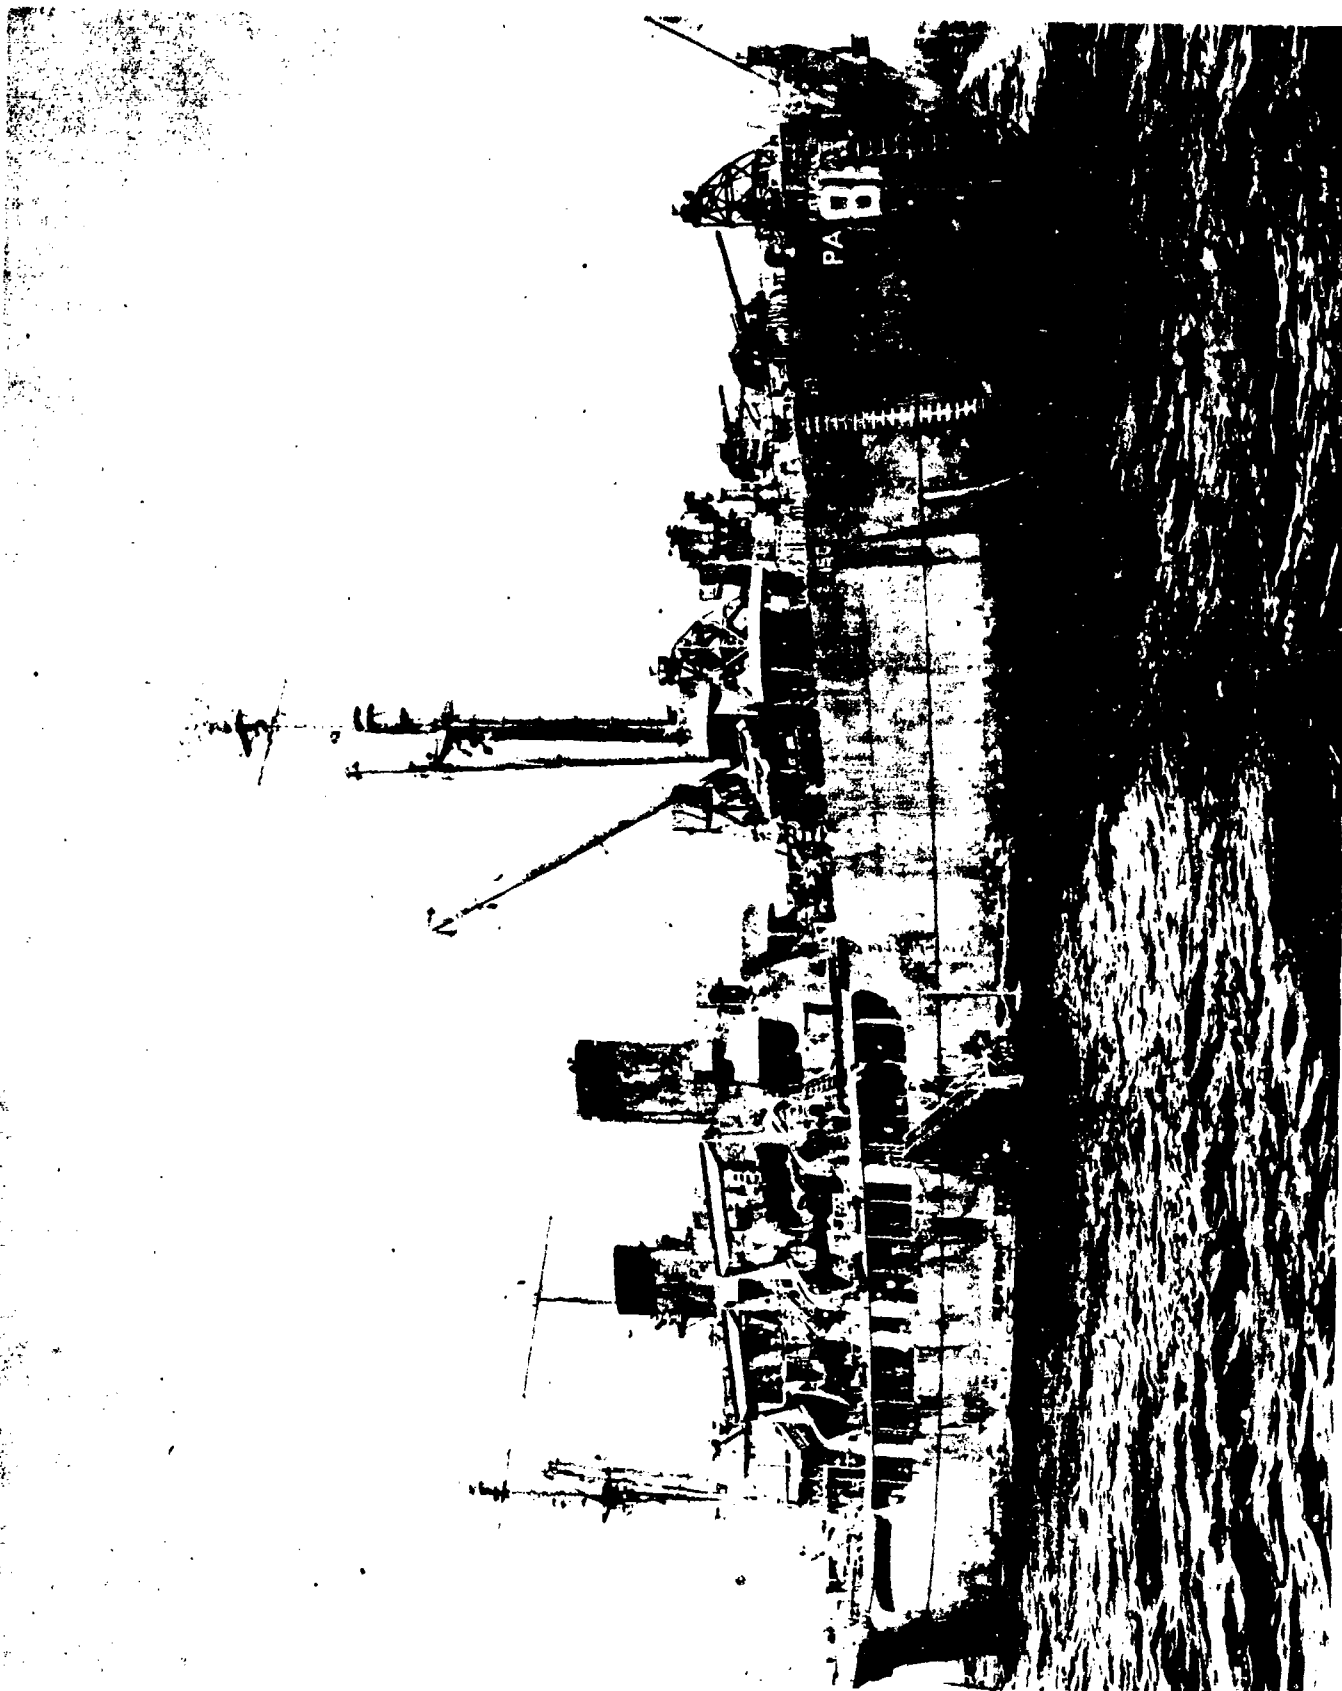
AA-CR-227-50-77. Exterior view on port quarter after Test A.

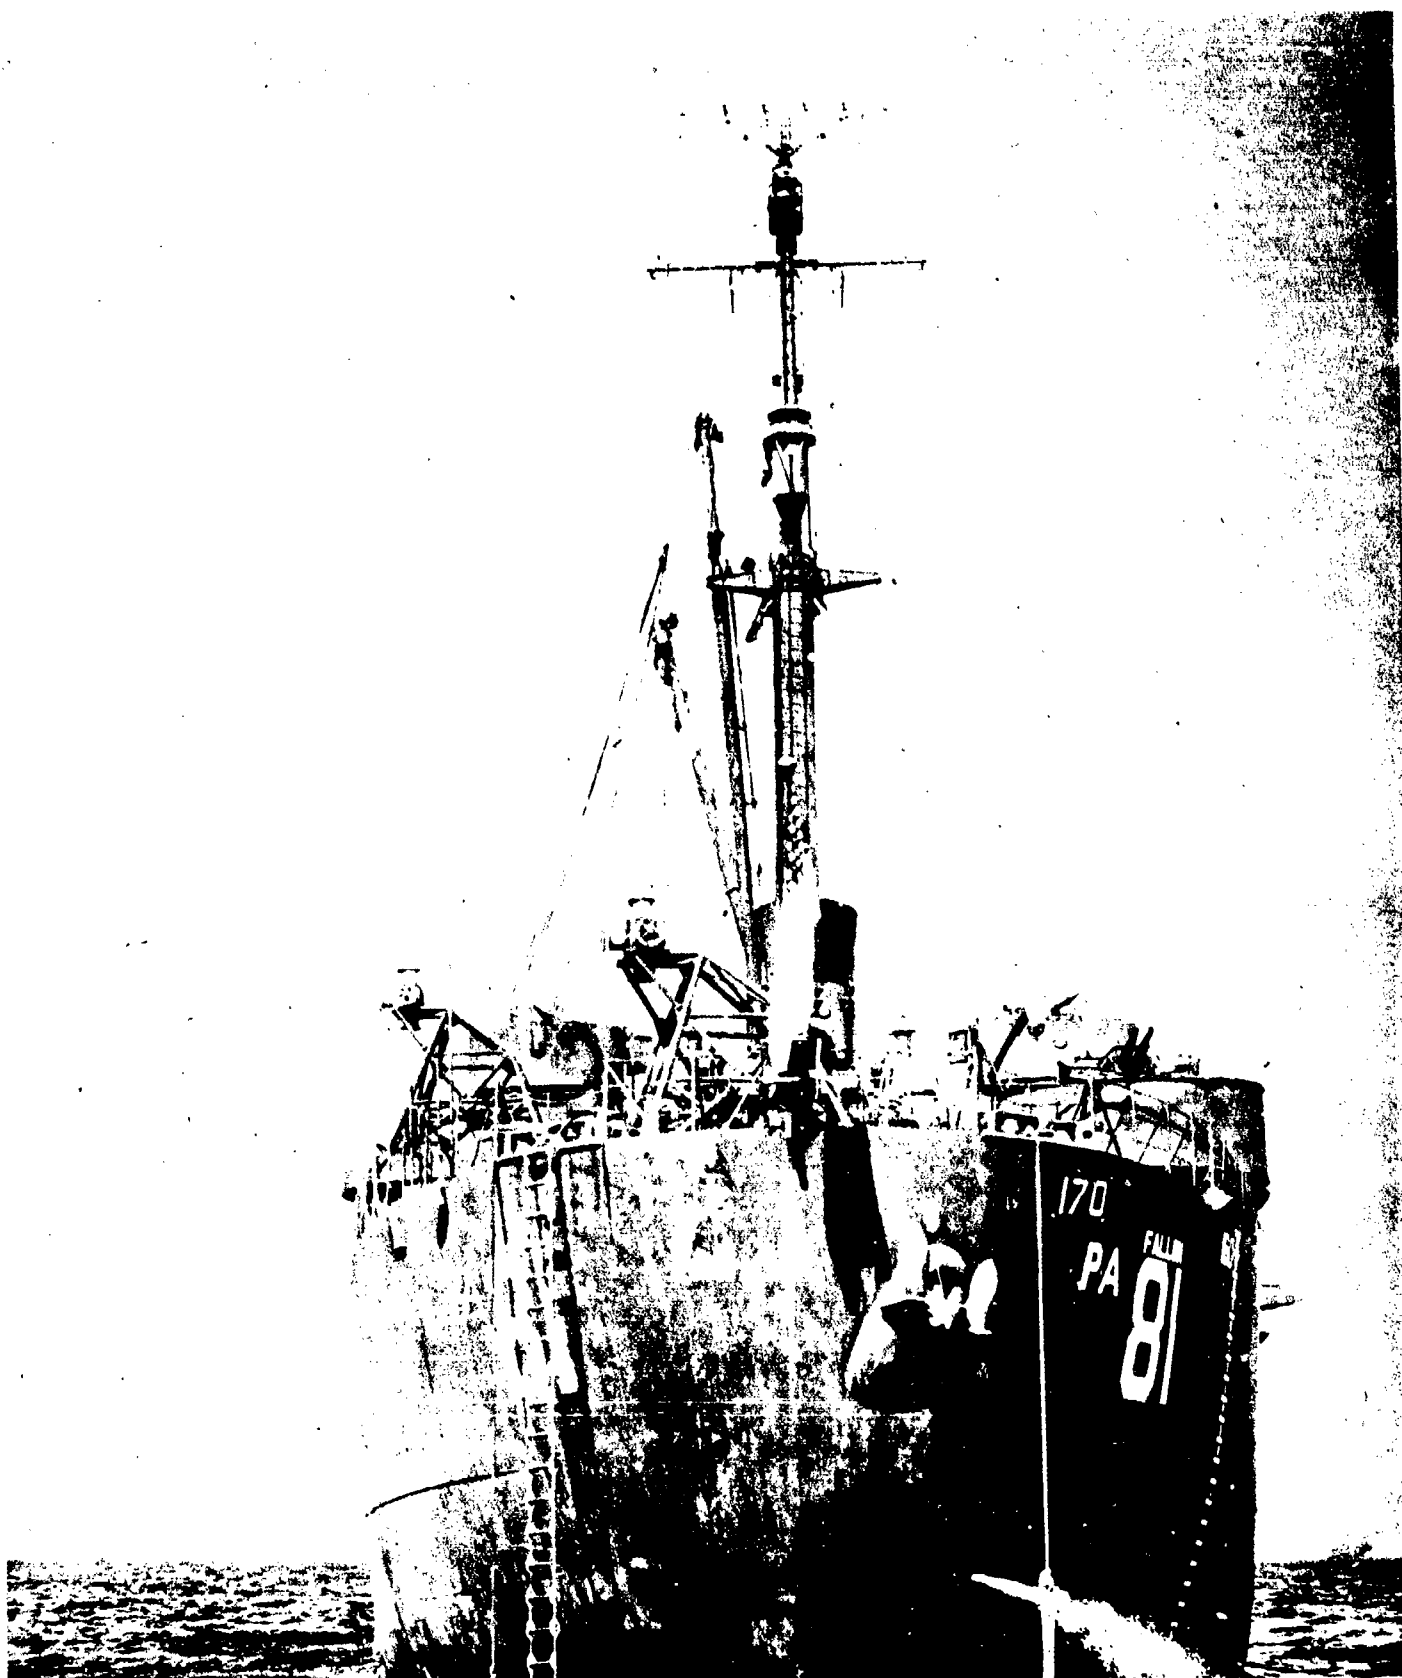
AA-CR-227-50-76. Exterior view from stern after Test A.

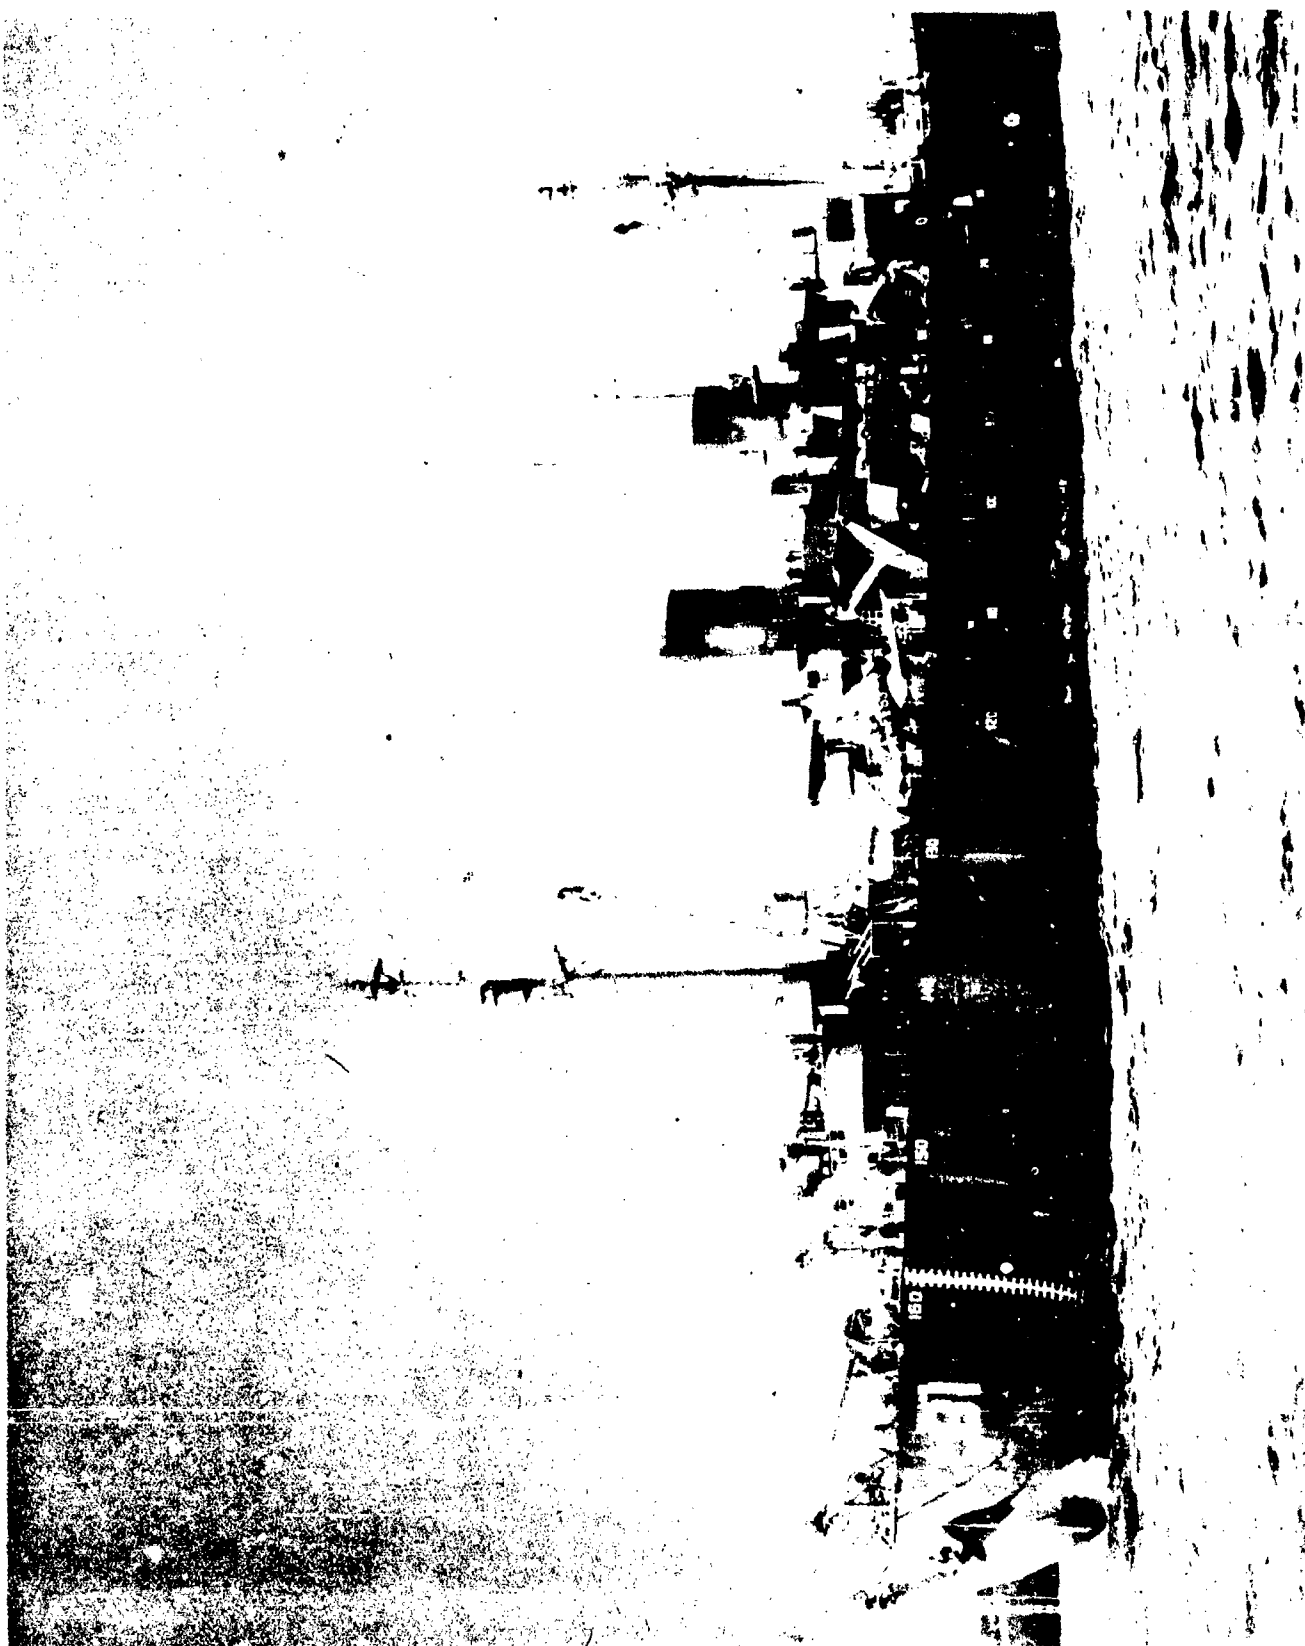
AA-CR-227-50-75. Exterior view on starboard quarter after Test A.

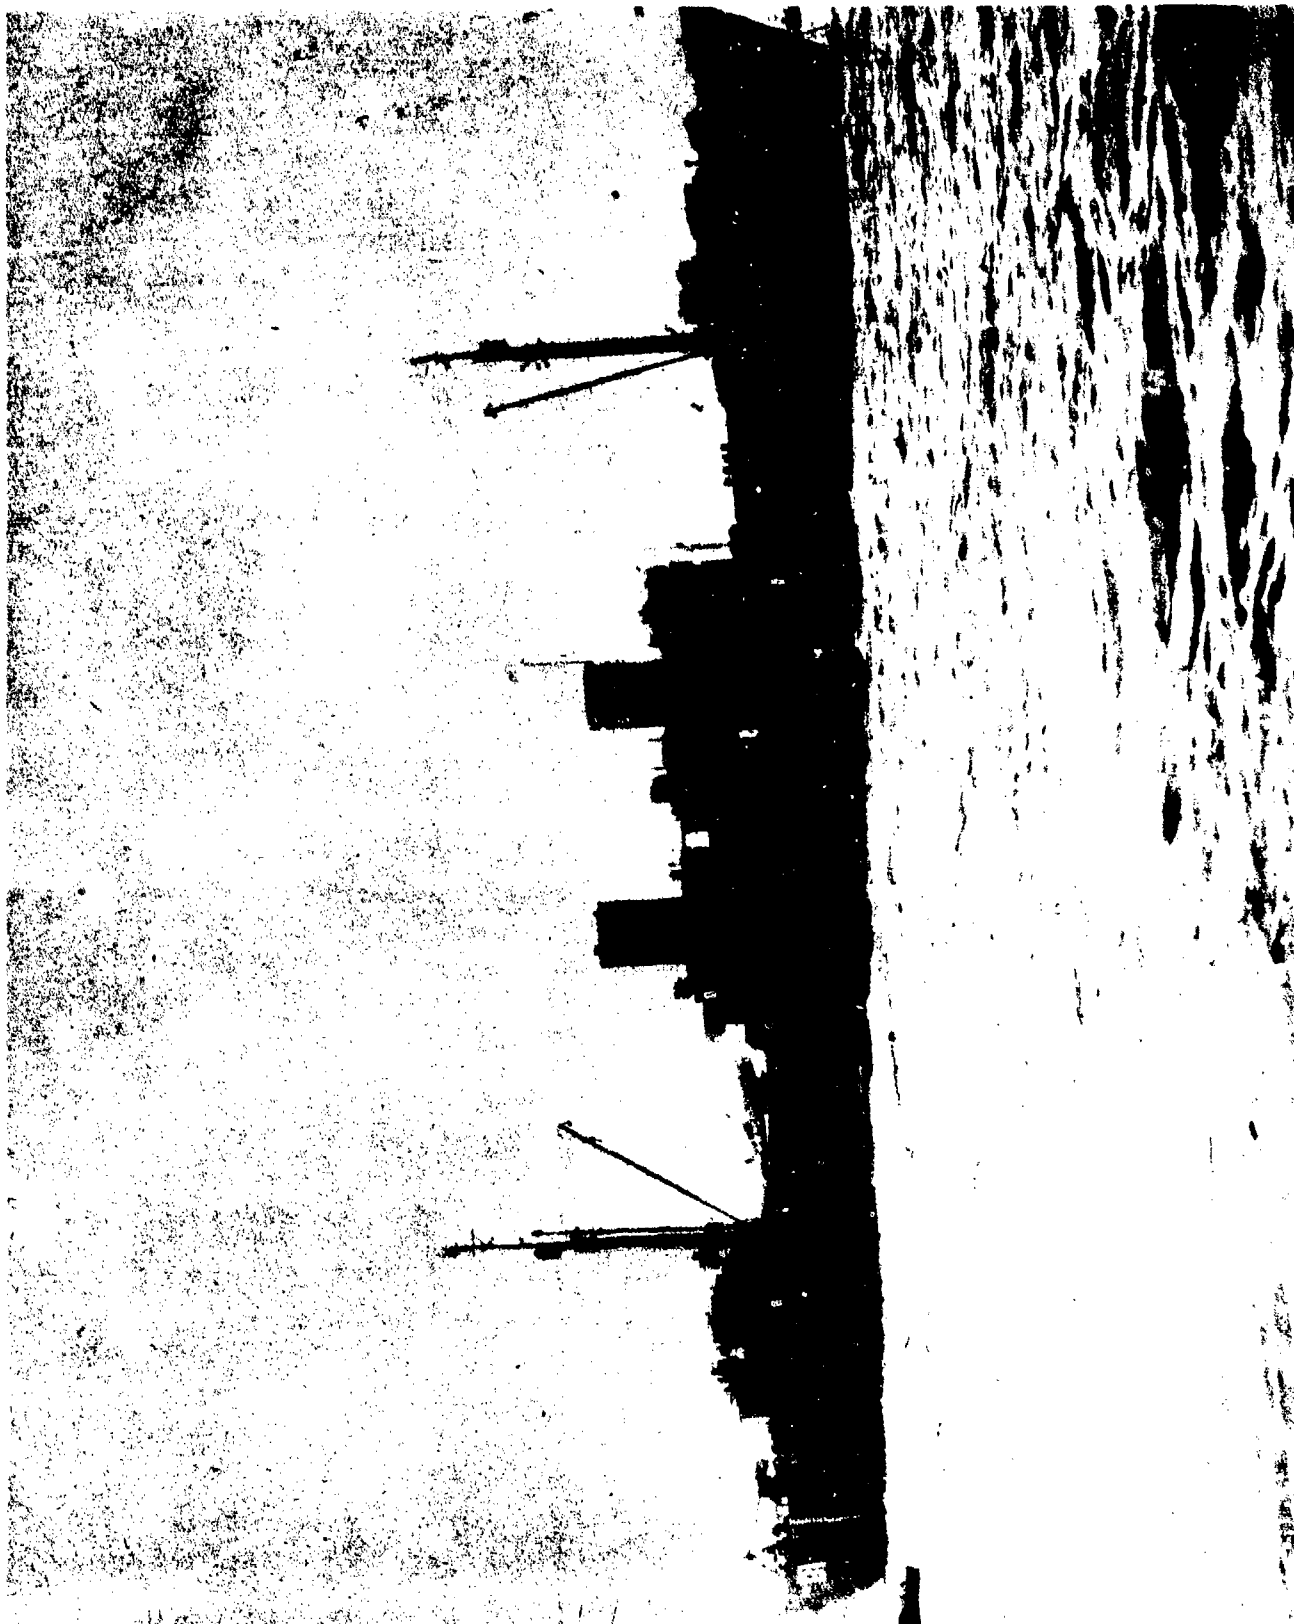
AA-CR-227-50-74. Exterior view on starboard beam after Test A.

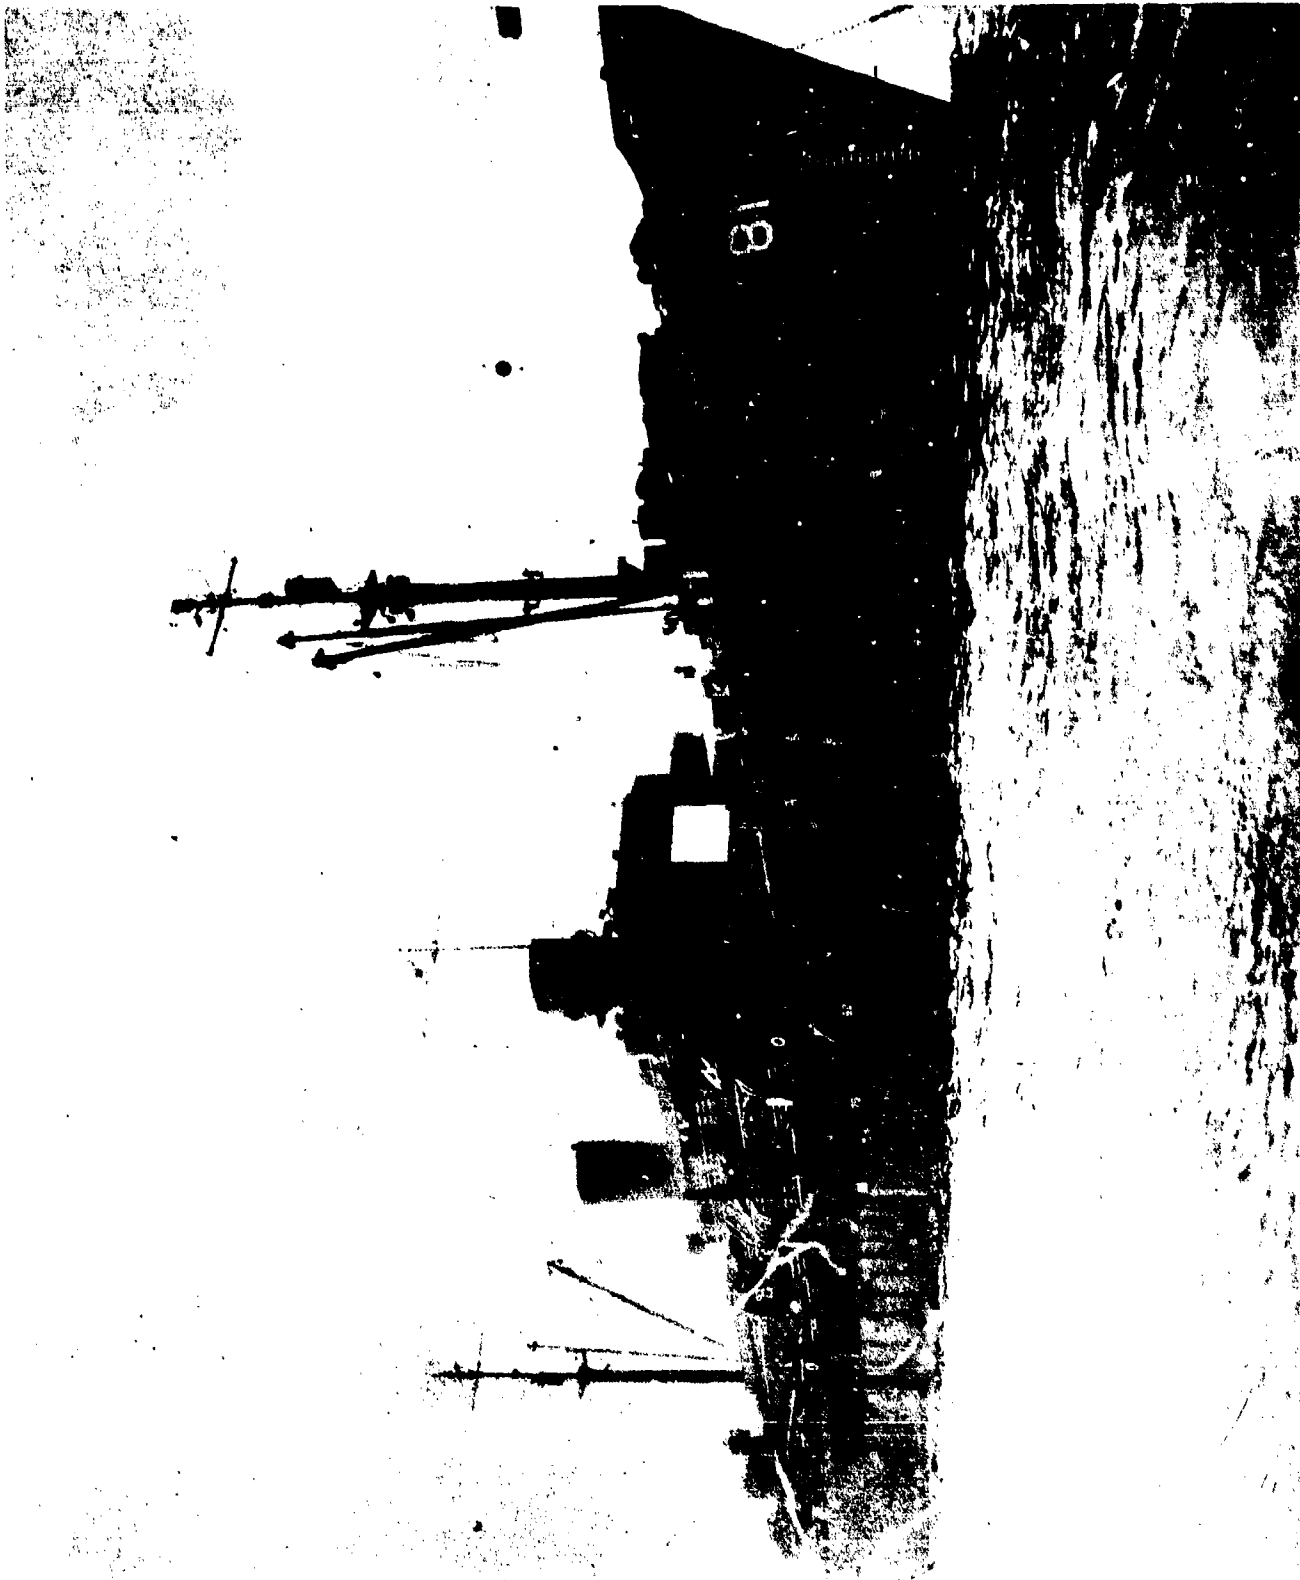
AA-CR-227 -50-73. Exterior view on starboard bow after Test A.

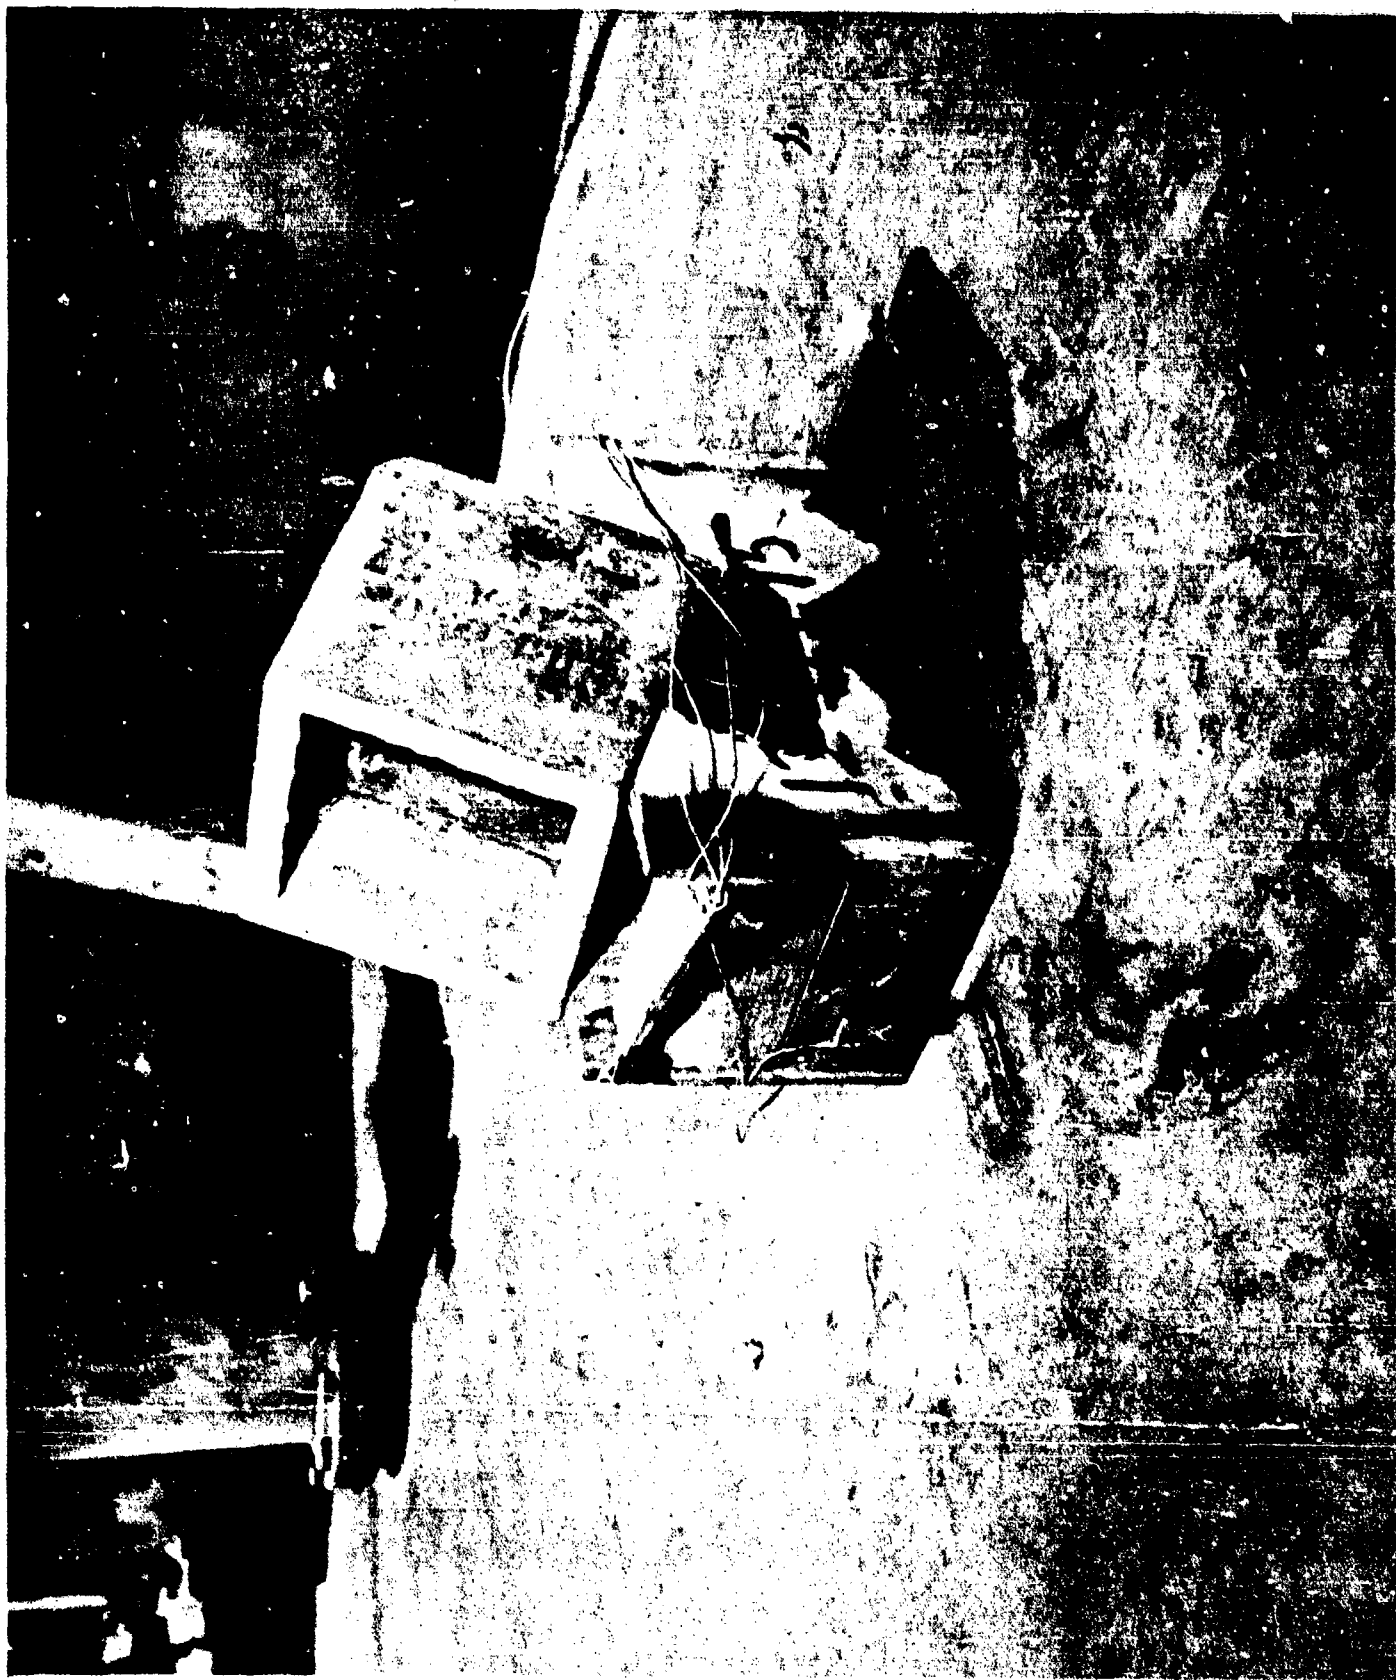
A wooden rack holding a lead box of lead plates separating photographic film was secured to the deck about 12' inboard of the waterway at about frame 43, port, by galvanized seizing wire. Before the test, the wire had been wrapped several times about the rack in a horizontal plane and looped over the top of the lead box. The ends of the wire were secured to clips on the deck. (Photo 1848-4, page 60). When the crew returned, they found that the wire had been broken; the lead box overturned towards the stern of the ship; and the rack was on its side. The wire remained wrapped about the rack. At the corners of the rack where the wire made positive contact with the wood, deep burning occurred. This phenomena appeared on all corners except that which was inboard after the rack had toppled, and which was behind the lead box. The position of the rack and lead box after toppling is shown in photo 1848-5, page 61 . It would appear from the burning effects that if the lead box actually shielded the unburned corner, the rack must have toppled prior to the test, although it had been considered stably secured by the medical crew that had installed it.

AA-CR-65-1848-4. Upper deck, frame 41, port, showing lead box and wood stand, rearranged to show position before Test A.

AA-CR-65-1848-5. Upper deck, frame 41, port showing lead box and wood stand, after Test A.

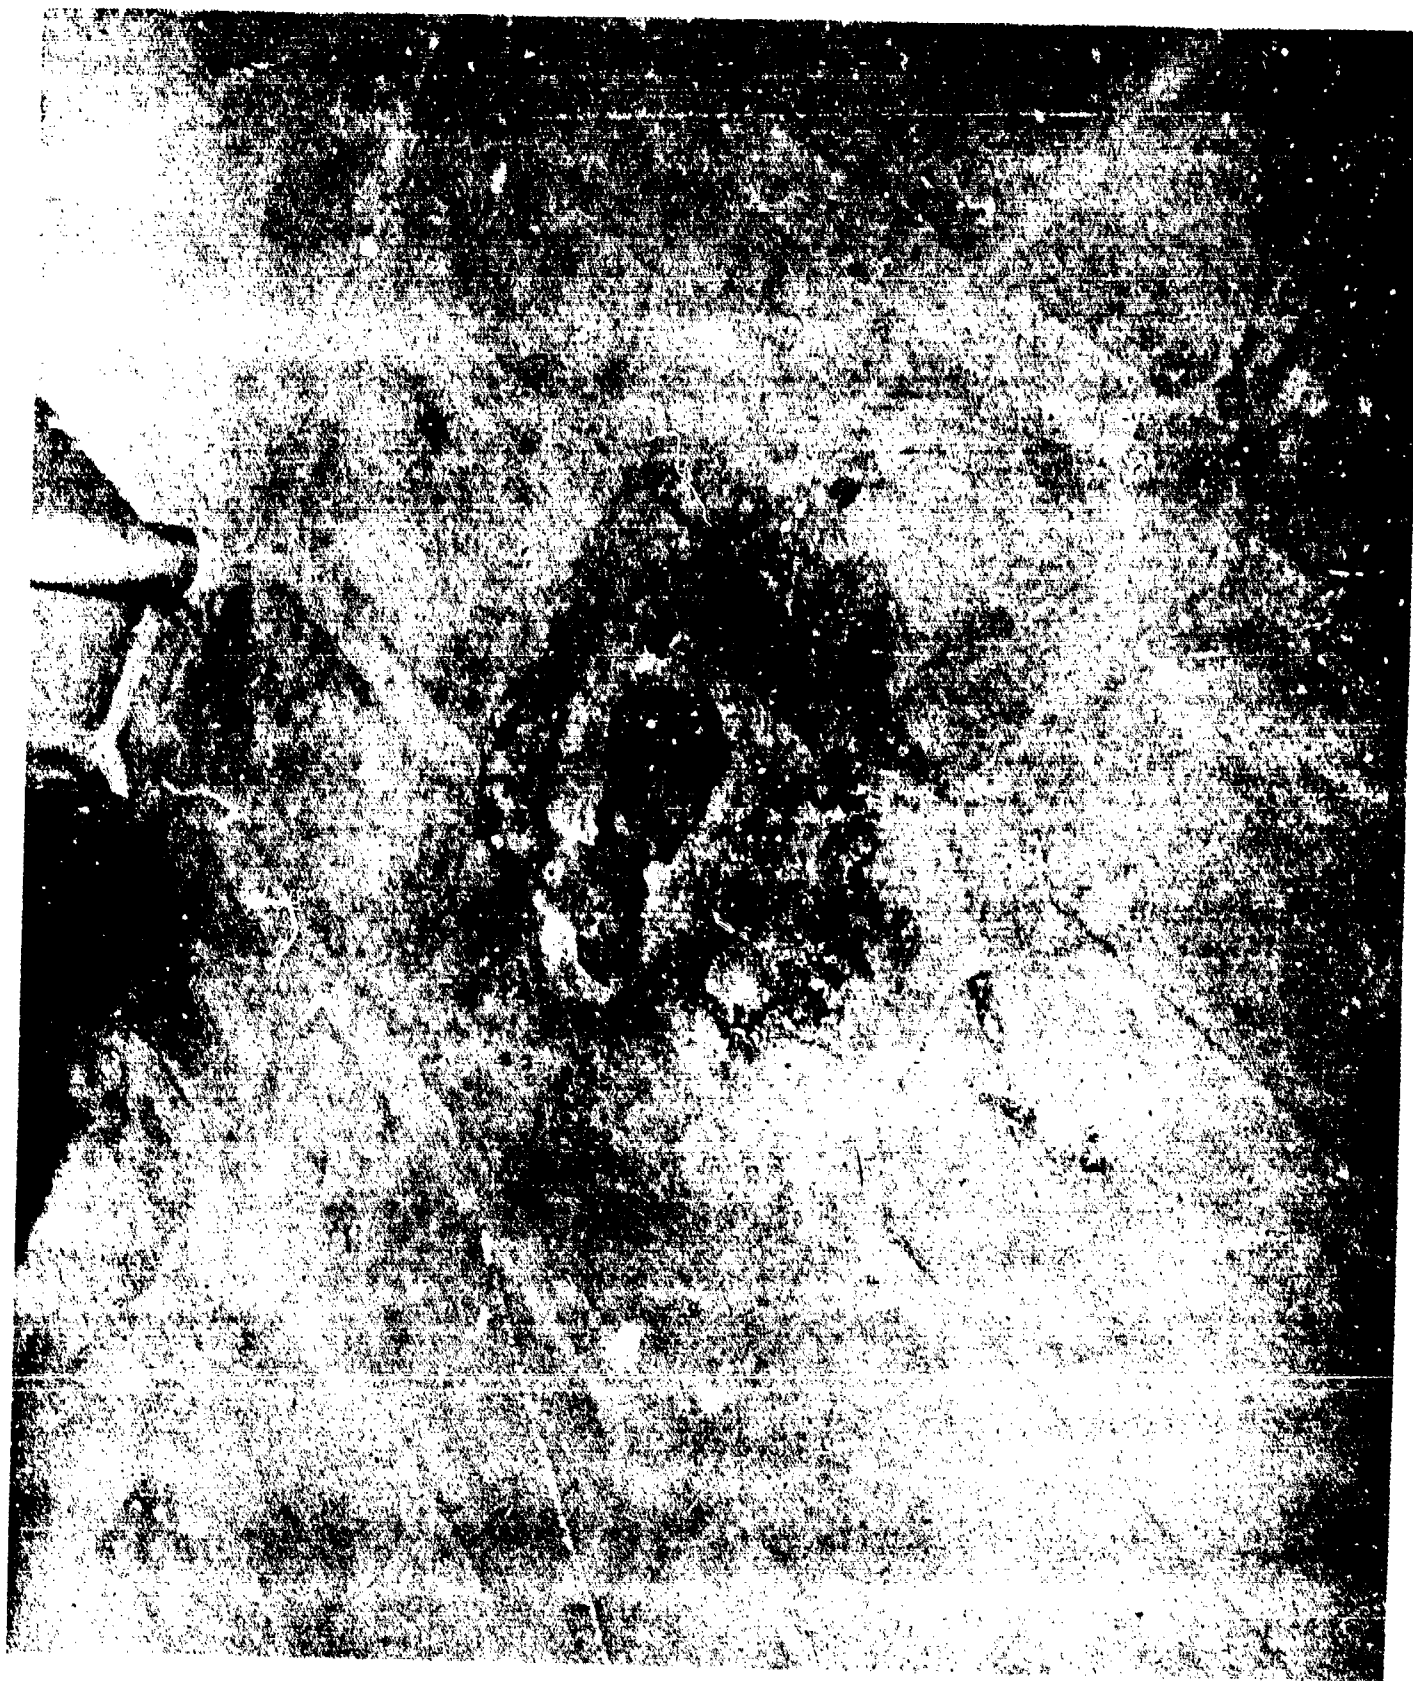
A rat cage of galvanized metal screening was hung from the starboard signal yardarm on the regular outboard signal halyard. A standard Navy kapok life jacket was wrapped about the cage in order that it might be kept afloat should it be blown overboard by the blast. The returning crew found that the halyard had been parted and that the rat cage had fallen to the deck

of the signal bridge, where it remained almost upright. A spot was burned in the deck painting approximately the size of the bottom of the cage. (Photo 1848-8, page 63). The life jacket was found to have been heavily scorched at the areas where it was in contact with the cage.

AA-CR-65-1848-8. Top of house, starboard, showing deck area burned by rat cage which fell from signal halyard.

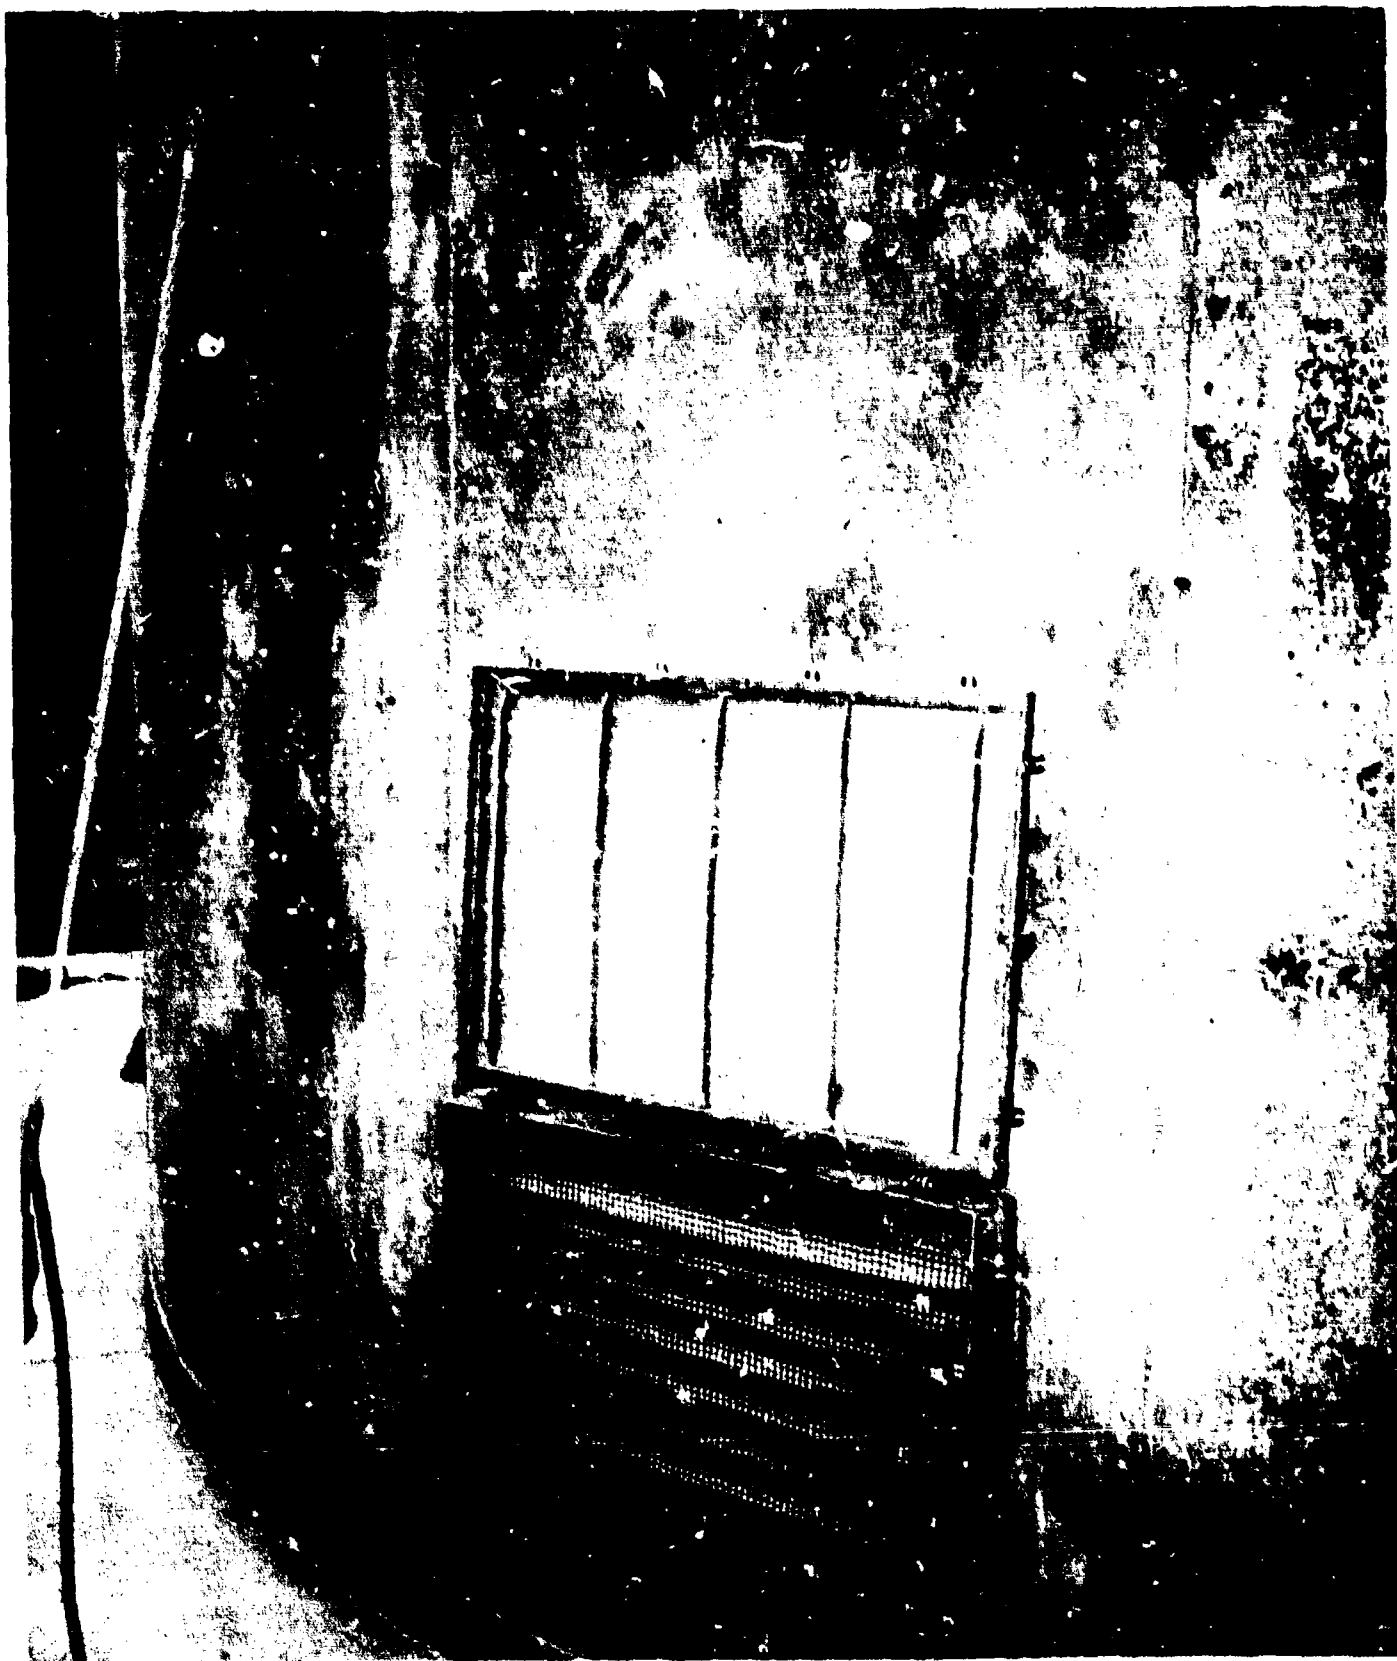
AA-CR-82-1914-2. Scorched paint on after stack, port side.
